## Special Committee of the Whole Meeting

January 24, 2018 at 6:30pm

5.1 Attachment B - Building Assessment Report	Information	Pg 4
---	-------------	------

# Stave Falls Preliminary Registration Summary - January 2018

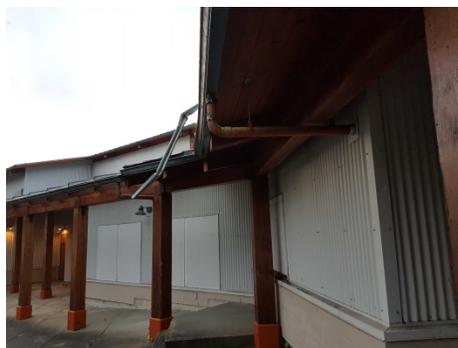
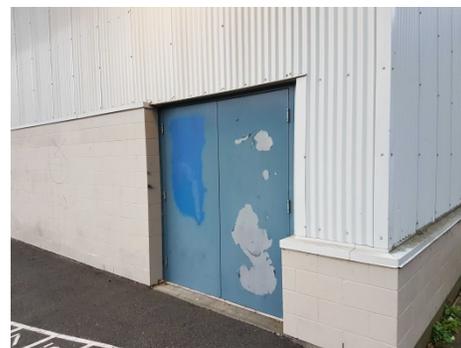
1. Building Exterior

Existing School and Grounds are in generally acceptable condition except for dirt and debris around the exterior of the building that could easily be pressure washed clean. It is obvious from approaching the school that it has been shut down for many years as all of the Ground Floor windows are boarded shut and these will need to be removed and any damage caused by the boarding repaired. There is some graffiti and other materials damage but these items are not critical to the opening and operation of the School. These could be items delayed after school is reopened for operation and could be dealt with by School District Maintenance forces.

From the road the school appears in relatively good state with the obvious items above and in the costing report to be covered.

| 1. Repair minor trim defects | \$7,500 |
| 2. Remove plywood covering over windows, inspect seal at windows, repaint exterior including posts and trims | \$17,500 |

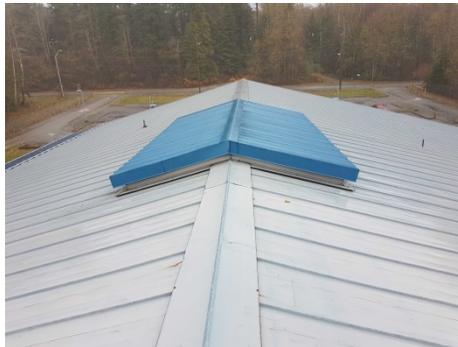
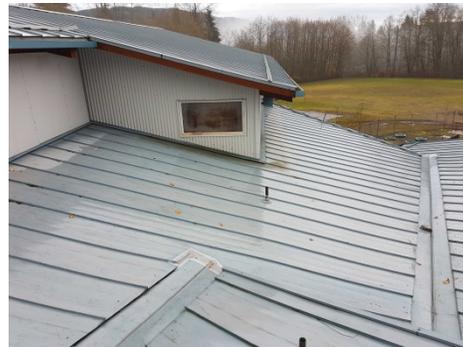
2. Roof

The existing roof consists of a standing seam metal roof system with rigid insulation installed over top of the wood decking. There should be consideration for the School District to put in their Operating Budgets in the medium term for the entire replacement of this roof. It is nearing the end of its useable life.

The roof, in general, is in acceptable condition except for the necessary repairs to the roof where there have been water ingress and leaking issues from the past. To avoid the disturbance of the operations if the school does open, these items should be repaired.

There are also several damaged snow guards, gutters and vents over the entire roof and these will need to be corrected / replaced prior to the opening of the school. All gutters and downspouts will need to be cleaned and inspected and any/all leaks repaired. All original skylights have been covered with metal cladding and this cladding will need to be removed and all skylights replaced with new skylights and sealed down to the roof.

| 1. Repair area where several valleys converge- divert water from upper gym away from this area (replace roof in the medium term- nearing the end of its useable life.) | \$ 8,500 |
| 2. *New Roof | \$ 175,000 |
| 3. Repair/replace roof snow guards | \$ 6,500 |
| 4. Seal roof at previous penetrations for snow guards | \$ 2,500 |
| 5. Repair/replace/clean out all existing gutters and downspouts | \$ 4,500 |
| 6. Remove existing skylights and flashing and replace with new skylights and flashing | \$ 19,500 |
| 7. *Replace damaged benches | \$ 2,500 |

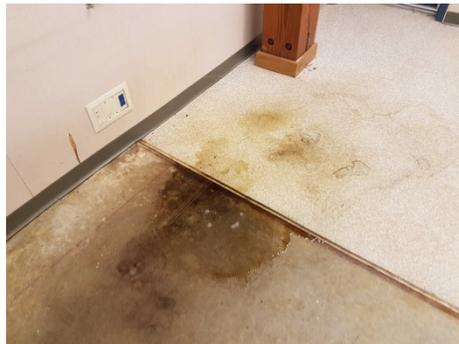
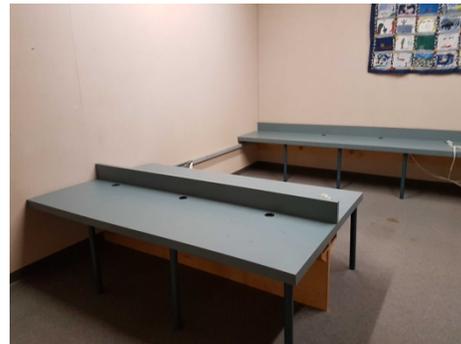
3. Interior

In general the inside of the school is in acceptable condition for opening since the School District has been maintaining the Mechanical systems to keep air movement within the building. The air quality in regards to odour does not appear to indicate excessive moisture but the air quality should be confirmed prior to opening.

There will be the obvious overall cleaning of the interior including all plumbing fixtures and surfaces as well as polish and seal all resilient flooring.

Existing carpets will need replacing in all Office and Classroom areas and replaced with either carpet tile or resilient flooring.

Entire gymnasium will need to be emptied and plywood protective flooring removed. Once exposed, existing gym floor should be inspected and cleaned.

All resilient flooring and base joint should be inspected and sealed as required.

| 1. Repair resilient flooring joints where pulling apart | \$ 5,500 |
| 2. Replace area carpets in each classroom with carpet tile or resilient flooring | \$ 27,000 |
| 3. Replace carpet in Admin area, Group Common Spaces and Library | \$ 10,500 |
| 4. Remove temporary plywood covering Gymnasium floor and inspect for defects and the need to refinish | \$ 3,500 |
| 5. Clean all floors | \$ 9,500 |

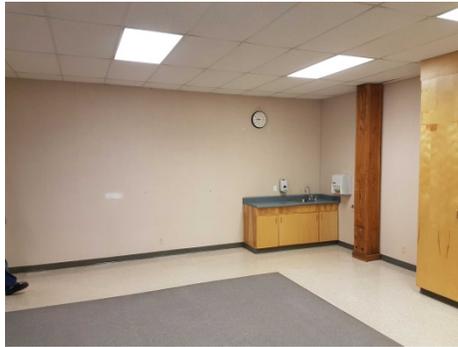
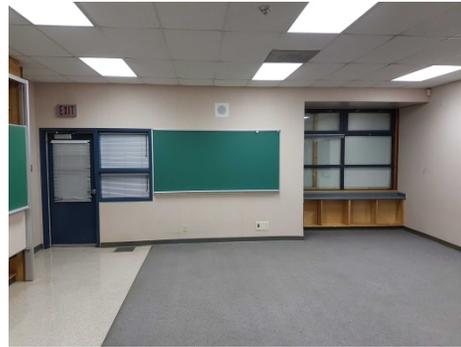
Walls

Entire school should have the walls patched and repainted. This may not be an entire repaint but doing so would provide a fresh and current colour palette to the rooms.

| 1. Patch and repaint damaged areas | \$ 7,500 |
| 2. *Repaint entire interior of school | \$ 35,500 |

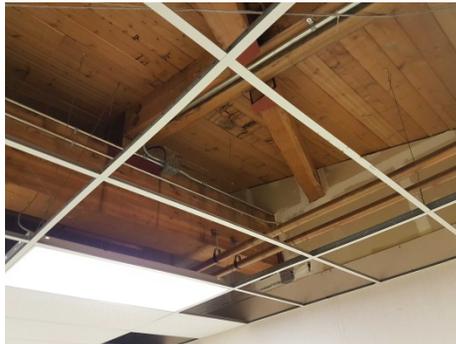
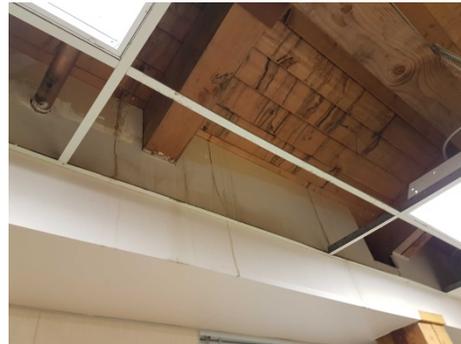
5. Ceilings

In general most of the ceilings are in good condition except where leaking has taken place and these panels and ceilings will need repairs once leaks have been repaired. A general overview of ceilings should be taken and consideration for at least a 10% replacement of tiles over the entire school.

- 1. Replace all damaged tbar panels \$ 3,500

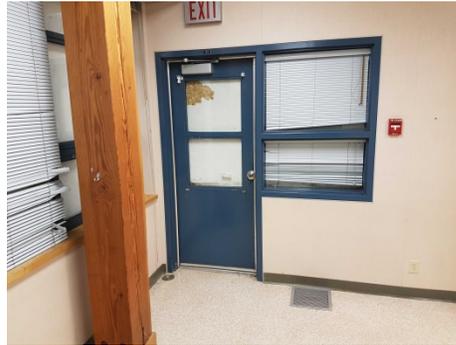
6. Doors and Frames

Door operation for the exterior of the school appears to be in good condition for the doors that were accessible during the visit. Once all plywood removed, all door operations will need to be reviewed and seals and hardware replaced / adjusted as needed. Time spent inactive could harden seals and fail closers and hardware.

Would recommend re-keying of the entire building to avoid any keys in existence that could access the old school. This will assist with potential new Teachers and provide keys to current standards.

- 1. Replace all broken hardware \$ 8,500
- 2. Check all closers and weather-stripping for fit \$ 4,500

- 3. Ensure Keying is still to District standards

\$ 2,500

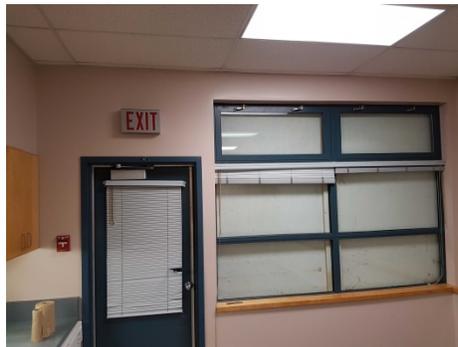
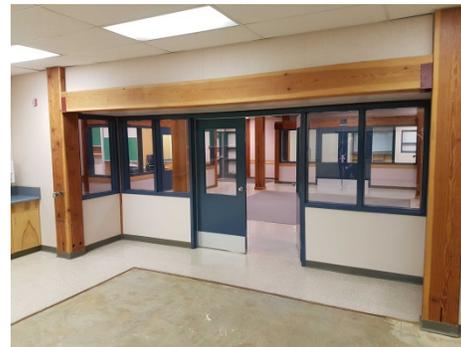
7. Windows

As the existing windows have been boarded up for almost 10 years, there could be substantial seal degradation for all windows and these should be inspected, tested and replaced if found to be faulty. Operations for any opening windows should be inspected and repaired as needed.

Replace any cracked or damaged panes of glass for exterior or interior windows. All windows should be cleaned.

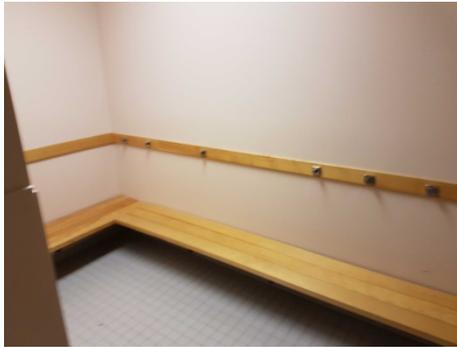
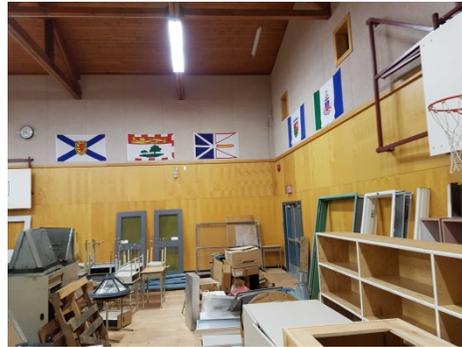
8. Millwork

Millwork appeared to be generally in good condition to the extent that it exists. There were no Teachers desks visible and these would need to be added as needed to the classrooms that will be filled.

There are some hooks missing from the Change rooms and there may be some other minor items requiring repair but nothing extensive to cause operations issues.

- 1. Generally in good condition – clean millwork \$ 3,500
- 2. Ensure all shelving is fully supported \$ 1,500
- 3. \*Teacher and Admin desks \$ 1,000/desk

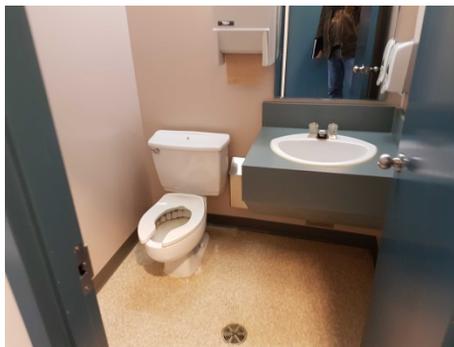
9. Miscellaneous

Many of the items within this category are cosmetic in nature and could even be carried out by School District staff or the returning educators if the school opens.

It would be required to inspect and replace as necessary all Fire Extinguishers as well as update the Fire Safety Plans as they are very yellowed with age.

This will be an item covered under Electrical but ensure that all Smokes, Heats etc are confirmed to be operational for the function of the Life Safety items.

Washroom accessories would need to be inspected for their function and assessed if new or additional units are required.

| 1. Install new fire extinguisher at Entry. Check all other extinguishers and replace as necessary | \$ 5,500 |
| 2. Check washroom accessories for fit and function | \$ 4,500 |
| 3. Rehang school photographs | \$ 1,500 |

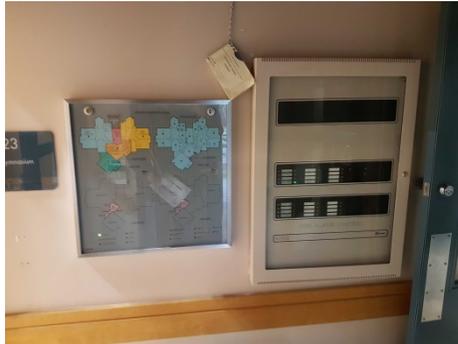
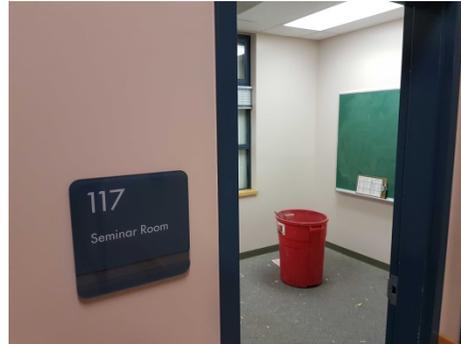
10. Signage

Review Room Signage and add/upgrade as needed or as missing. Review existing Annunciator panel for room numbering to ensure all room match

1. Replace signage where room numbers don't match annunciator panel \$ 4,500

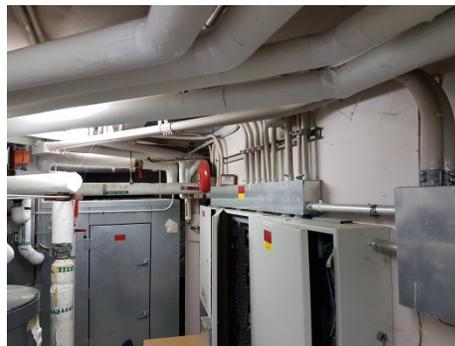
11. Boiler Room

Review the existing Boiler Room Fire Separations and update Fire Caulking / Separation to ensure integrity of rated separations. It would be advisable to review all Fire Ratings/Separations as per the existing drawings to ensure compliance.

Review of existing ducting to ensure all Fire Dampers are in place and functioning as required. Suggest replacement of fusible links for existing dampers.

1. Ensure room is separated from the building by properly sealing all penetrations and openings \$ 3,500
2. Install dampers as required to maintain separation \$ 7,500
